Report Number: 14110934

This report details the results of tests carried out on Pressed Swivel Coupler Zinc Plated used for connecting steel tubes of 48.3mm outside diameter and of at least 3.2mm nominal wall thickness at a minimum in the construction of working scaffolds and falsework required for the construction, maintenance, repair and demolition of buildings and structures.

Pressed Swivel Coupler Zinc Plated

The couplings have been tested in accordance with the relevant sections and requirements of EN 74-1 :2005.

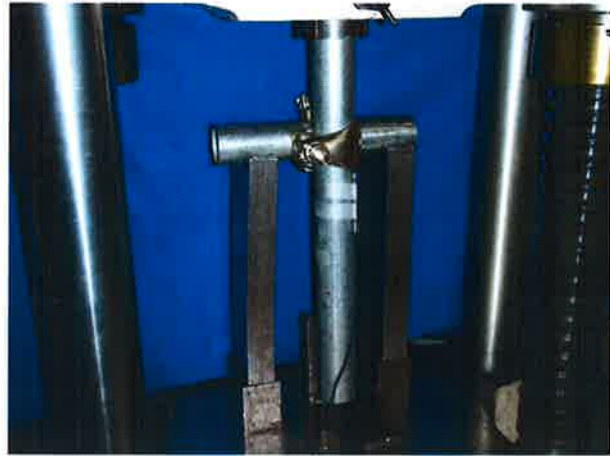
Photograph of Setup for Slipping Force

The photograph above shows the setup for slipping force but is not necessarily the coupler under test.

Slipping Force Tests, tested in accordance with Clause 7.2.1

From the results, the prototype is Accepted to Class A for slipping force

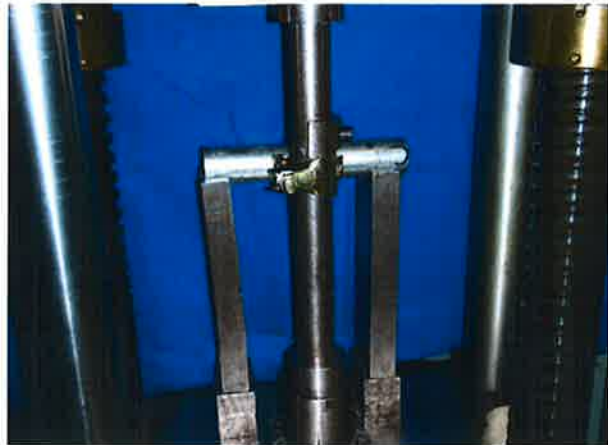
Photograph of setup for Failure Force

The photograph above shows the setup for failure force but is not necessarily the coupler under test.

Failure Force, tested in accordance with clause 7.2.2

From the results, the prototype is Accepted to Class A for failure force

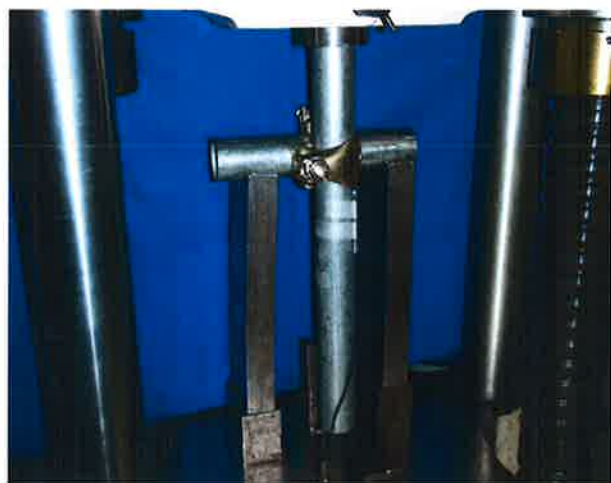
Photograph of setup for Indentation Check

The photograph above shows the setup for indentation check but is not necessarily the coupler under test.

Indentation Check, tested in accordance with clause 7.5

From the results, the prototype is Accepted to Class A for indentation check

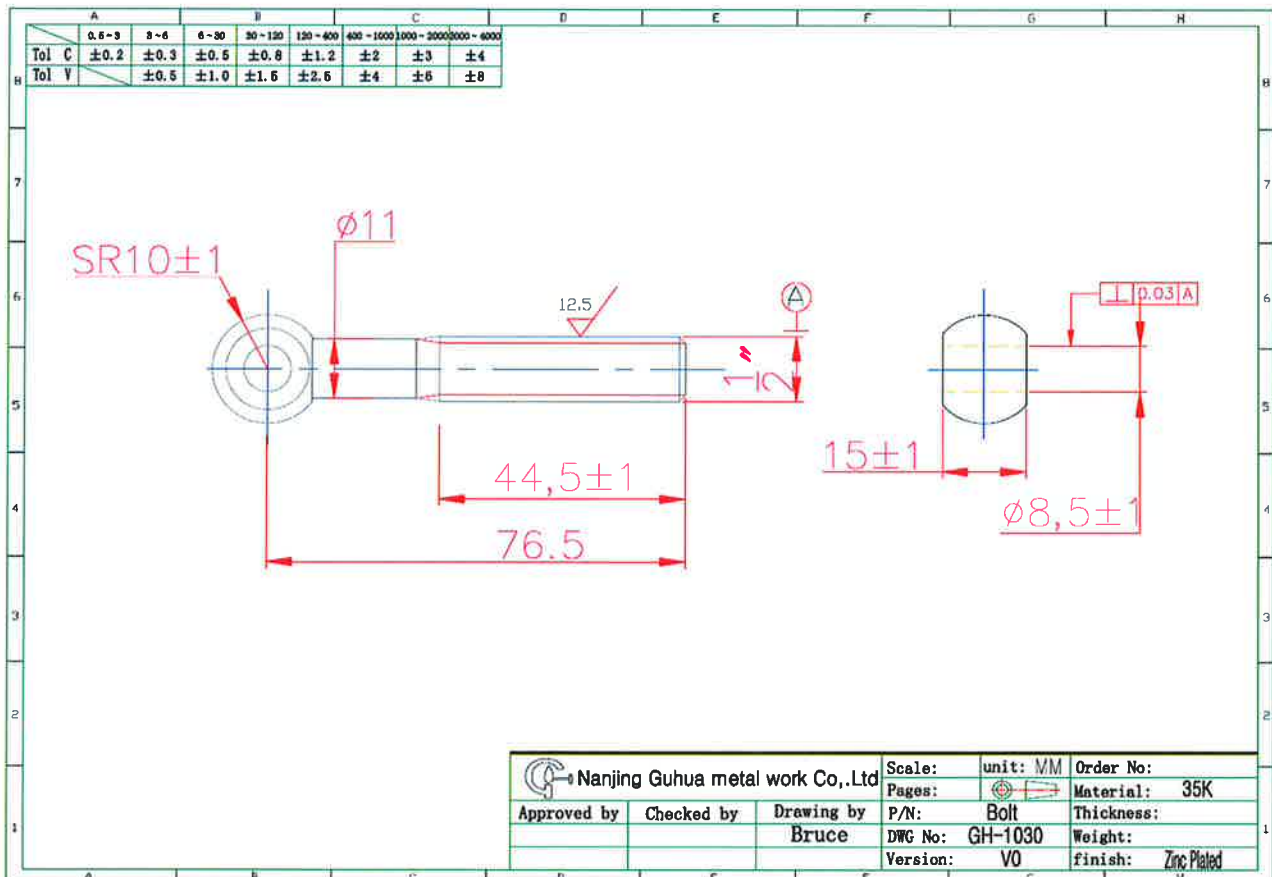
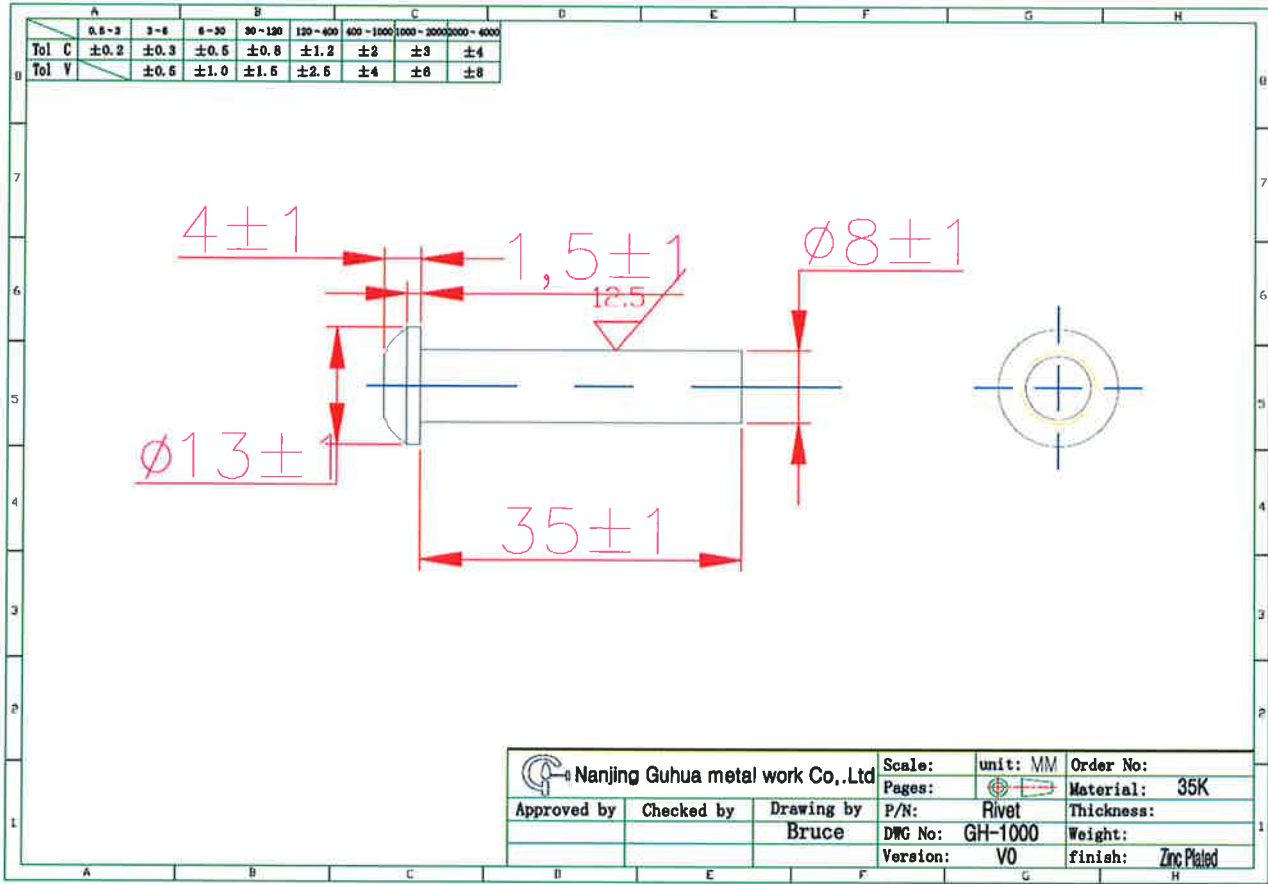
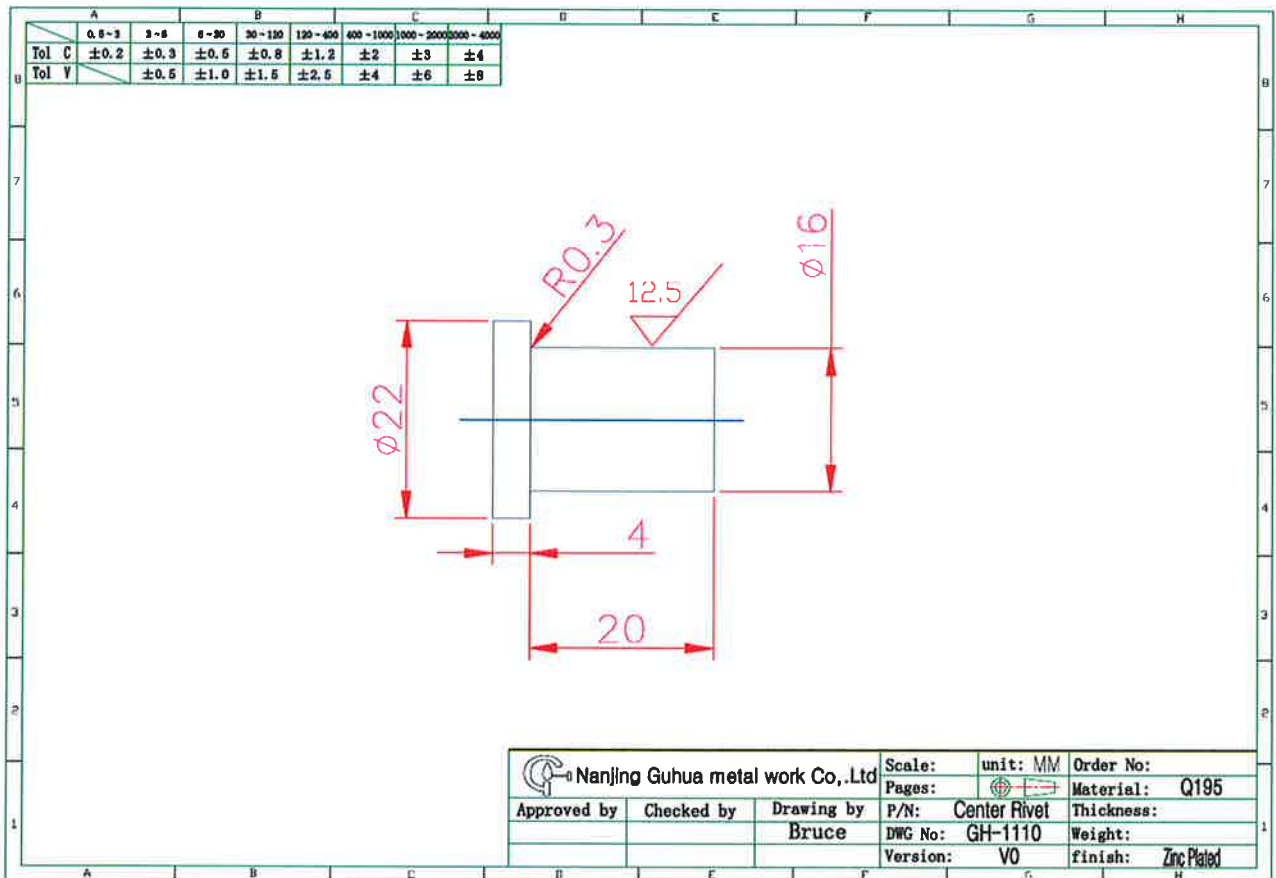
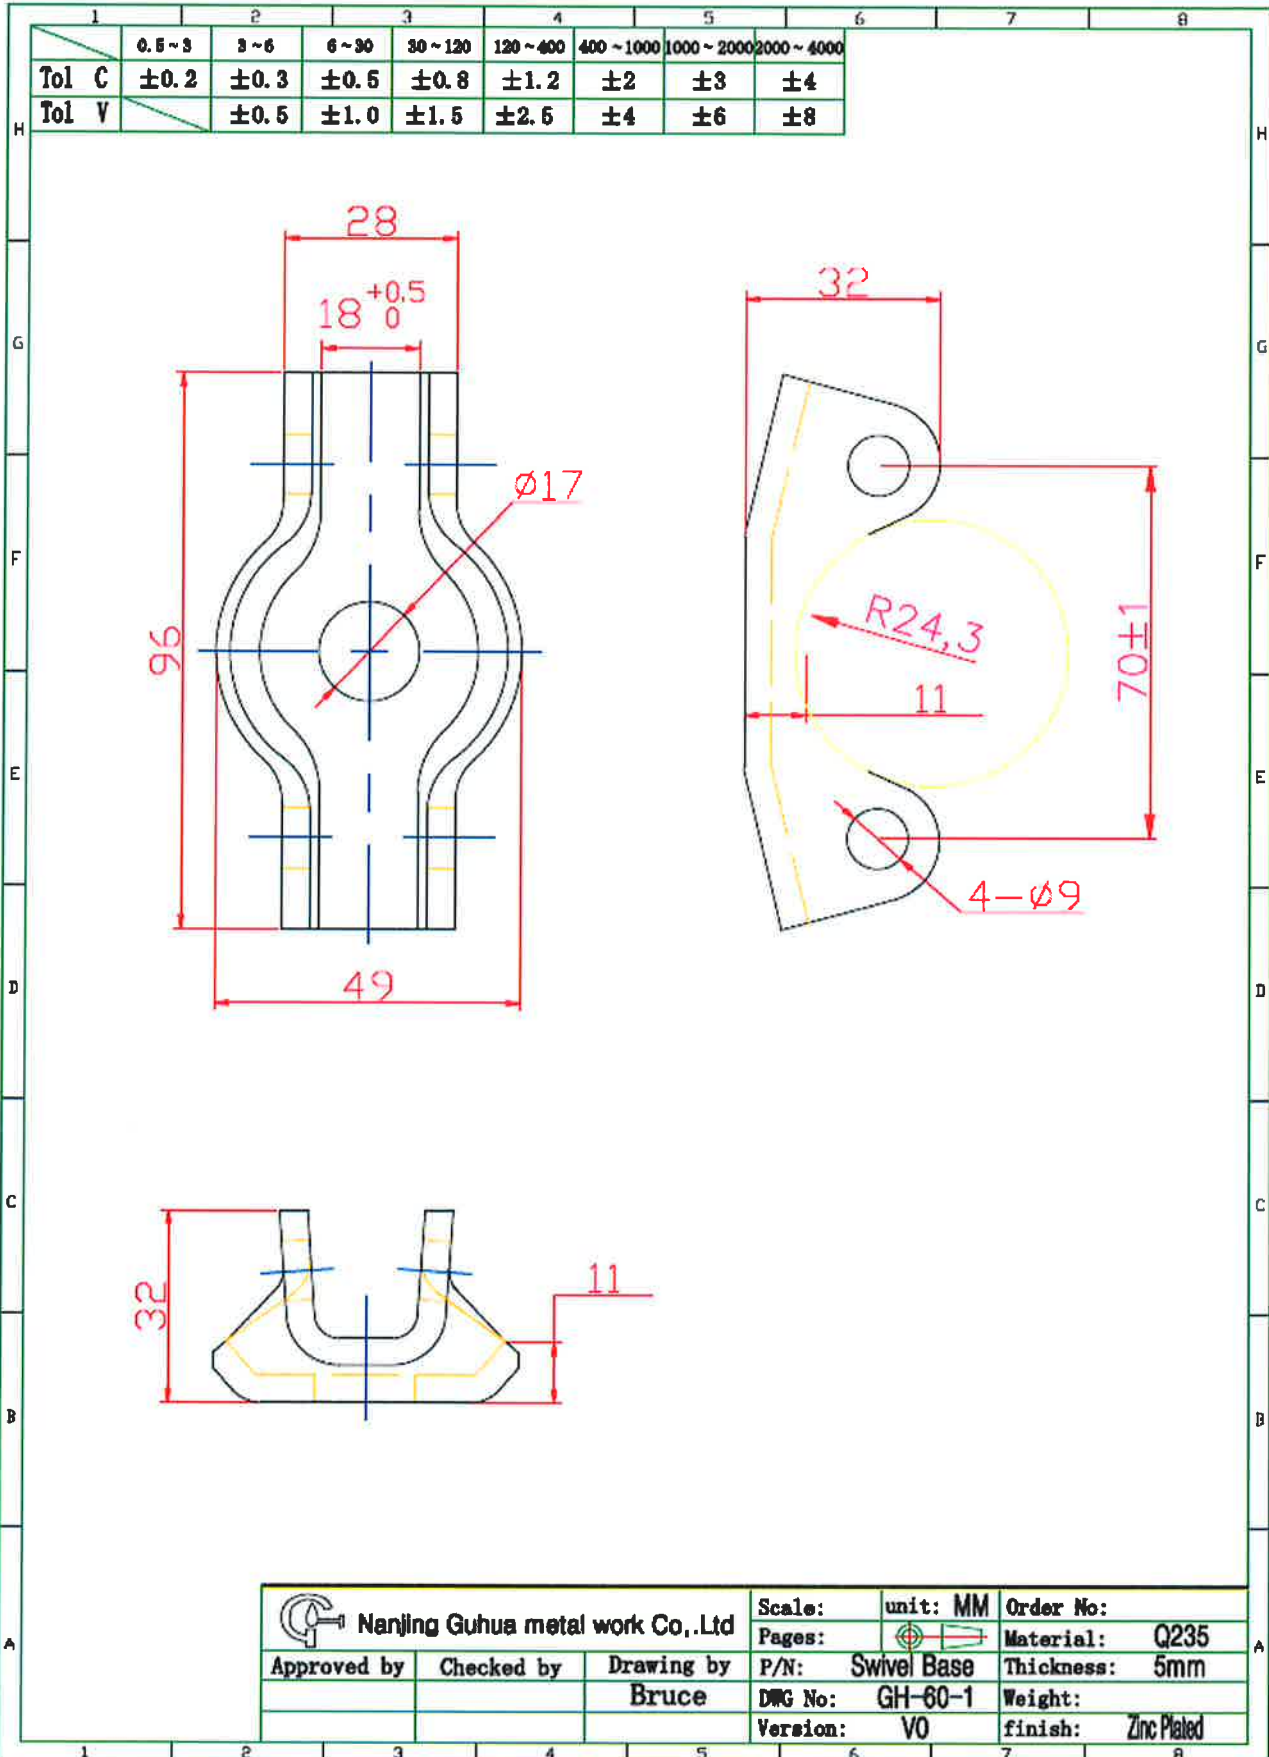
Drawings

Manufactured by: Nanjing Guhua MetalWork Co Ltd
Shape: As per drawings shown at the end of this report
Dimensions: As per drawings shown at the end of this report
Mass: As per drawings shown at the end of this report
Material Characteristics: As per drawings shown at the end of this report

The measured dimensions, mass and material characteristics, of the couplings, were all within the tolerances as specified by the manufacturer. (Drawings are shown at the end of this report)

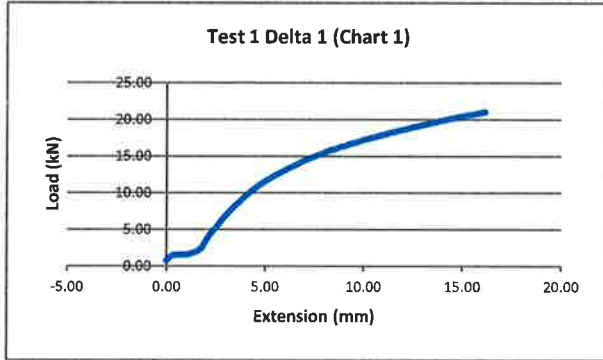
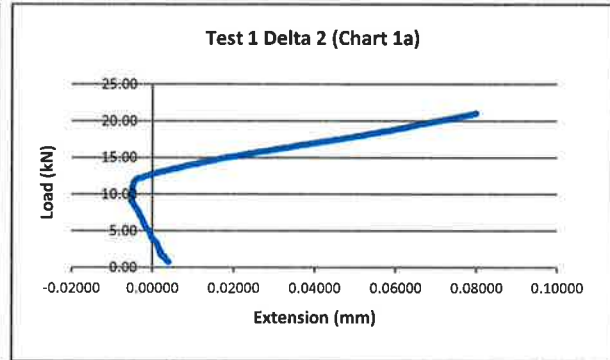
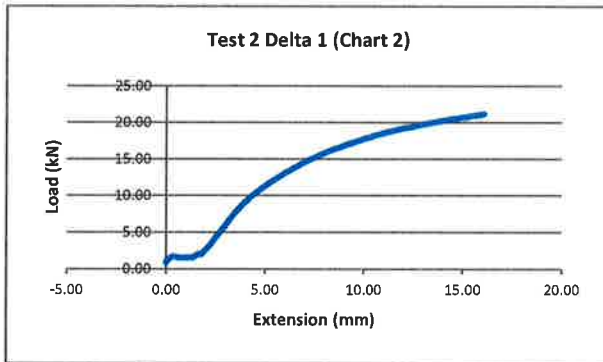
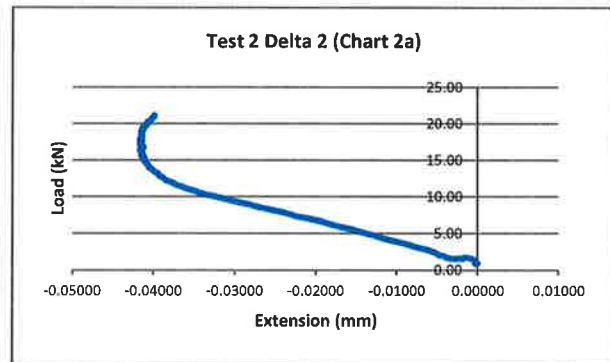
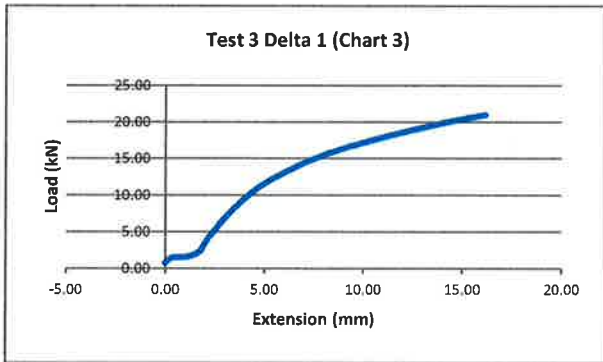
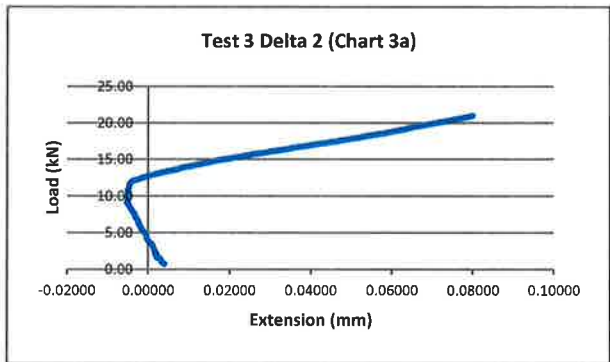
Load-displacement curves are shown in Appendix A as charts 1 to 15

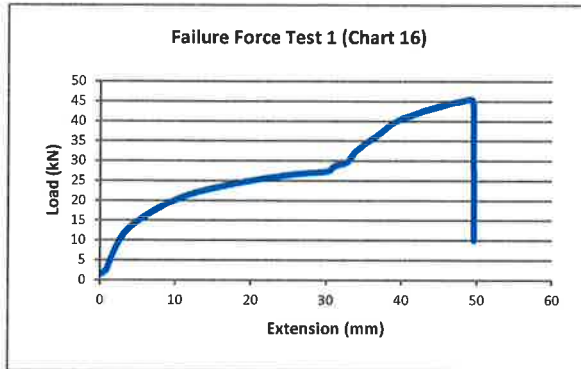
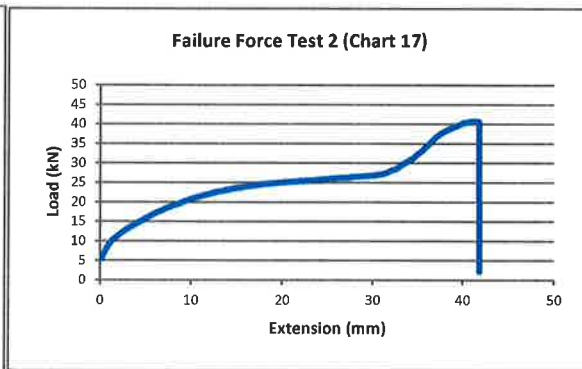
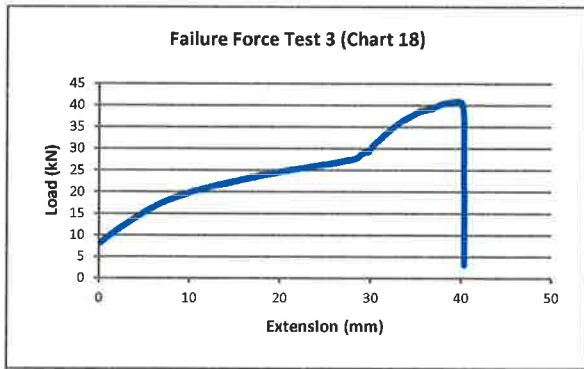
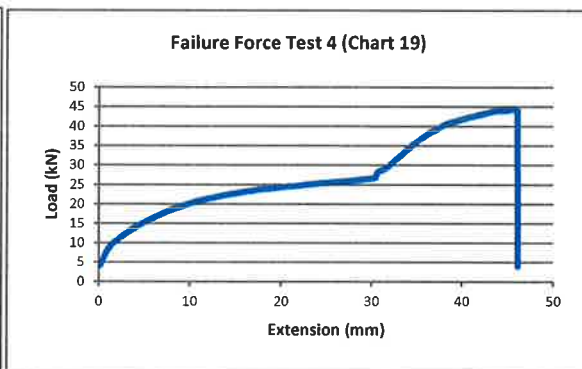
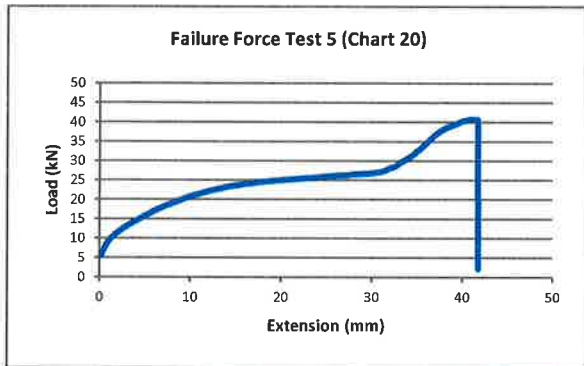
Load-displacement curves are shown in Appendix B as charts 16 to 20
